Rehabilitation of 150 m ENO Nováky chimney

Keywords: concrete, chimney, rehabilitation

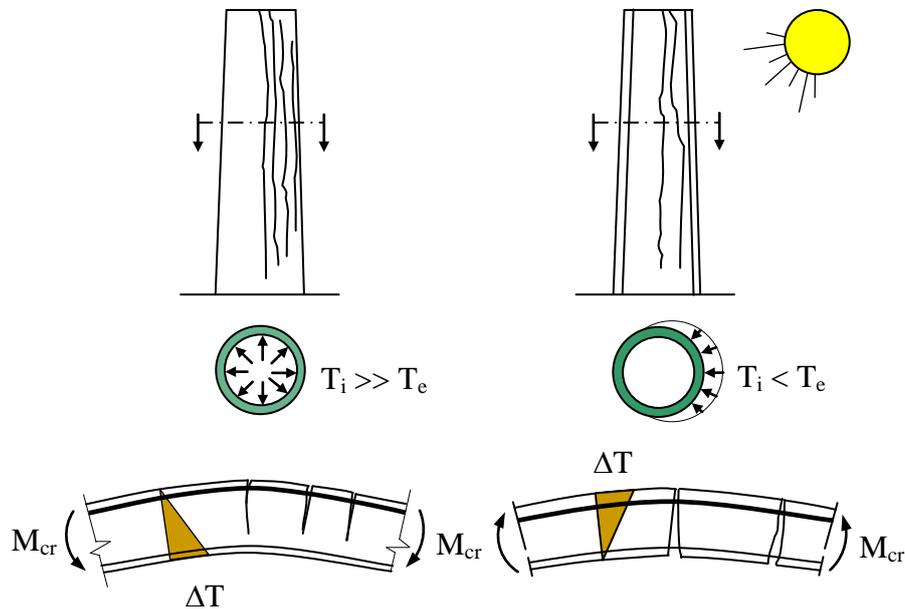
Chimneys, as cooling towers, belong among those constructions that are loaded primarily by their own weight, by wind, by seismic factors and the effects of temperature changes. In contrast to cooling towers, in chimneys there is a greater variance of temperature. This fact is accounted for by the high temperature of waste gases (to 300 °C). Even though the concrete construction is protected on its inner surface by a protective lining, in the majority of concrete chimneys it is possible to observe a small amount of vertical cracks of great length. The reason for the occurrence of such cracks is the horizontally acting of bend and tension on the concrete shaft of the chimney as a result of the differences in temperatures of the inner and outer surface. In the winter season, when the internal temperature, during the operation of the chimney, is greater than the exterior, vertical cracks appear on the outer surface (Fig. 1A). If the chimney is not in operation, during sunny weather an opposite temperature difference occurs, producing tension on the interior side of the shell, which is often not reinforced, thus leading to the occurrence of a smaller amount of wide cracks. (Fig. 1B)

Fig. 1. Appearance of vertical cracks in chimney shaft due to temperature gradient

In situations of insufficient reinforcement of the chimney shaft by horizontal reinforcement on the outside surface and the frequent absence of reinforcing on the interior surface, wide vertical cracks appear. If the stress on the horizontal reinforcement is greater than the yield value of the steel used, a plastic behavior occurs in the reinforcement in the crack, along with an increase in the width of the cracks. If at the same time we take into account the continuing corrosion of the reinforcement in the crack, it is quite likely that in the course of several years there an increasing width of the cracks will take place, leading to a division of the cylindrical cross-section of the chimney shaft into a number of more or less independently acting segments. The cross-section has an essentially unfavorable division of the vertical stresses if the cracks are spread throughout the whole thickness of the shaft, and the deflection of the chimney will increase due to the effects of the horizontal load.

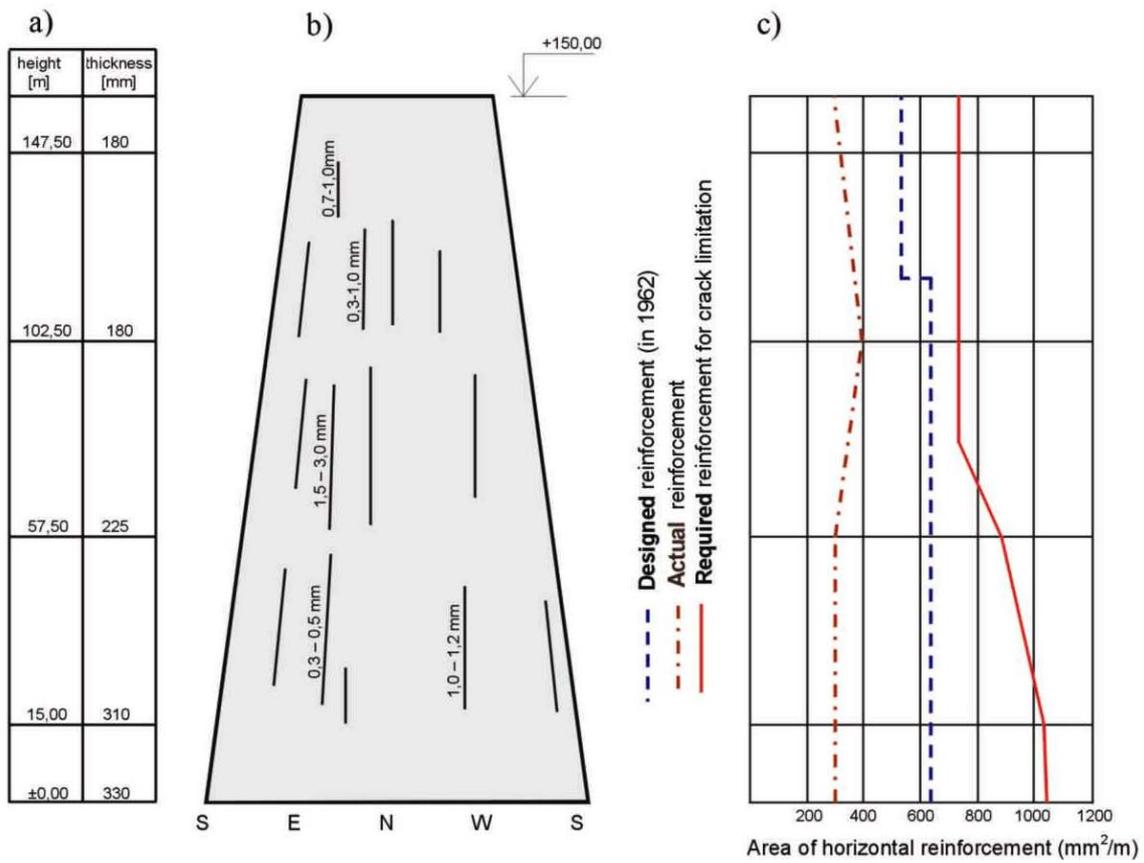
The reinforced concrete shaft of the ENO chimney has a diameter of 10,95 m and a thickness of 585 mm in its lower part, on the upper edge a diameter of 6,84 m and a thickness of 180 mm. The actual degree of the shell reinforcement by horizontal cylindrical reinforcement on the outside surface, ascertained by a Proceq SA profometer, along the height of the chimney ranged around 0,1% to 0,21 %. According to the projecting documentation, the inner surface is without reinforcement. The temperature in the chimney of non-desulphurised waste gases was $175 \pm 15^\circ\text{C}$.

In 1994, vertical cracks reaching a length of several meters and up to ten meters were recorded on the shaft, with widths from 0,2 to 1,8 mm. By long-term tracking of the dynamic of the width of these cracks it was found that the width of the cracks was progressively increasing. As the calculations showed, this state is the result of the plastic yielding of the reinforcement at the crack places due to under-dimensioning of the horizontal reinforcement of the chimney shaft, which is stressed over the yield point. After inspection in 2001, on the shell were recorded vertical cracks of widths of 0,3 to 3,0 mm (Fig. 2, 3). On the basis of these facts, the owner was advised to strengthen the chimney shaft, which would stabilize the width of the existing, and prevent the formation of new cracks [1].

Fig. 2 Pattern and width of cracks on the developed surface of the chimney shaft, comparison of the actual, projected and required area of horizontal reinforcement

The criterion for the reinforcement necessary for strengthening the chimney was the achievement of such a state of stress at which the width of the cracks from temperature loading would not exceed a width of 0,3 mm, and the stress in the concrete reinforcement a standard yield value of 400 MPa (Toros 10 492 reinforcement).

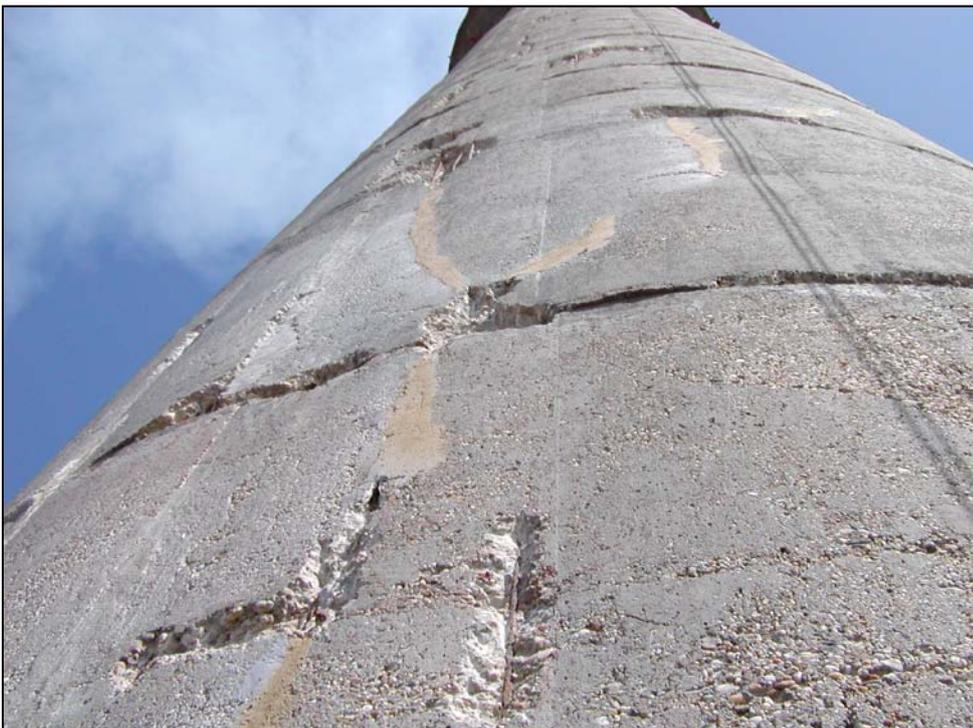
Fig.3 Cracks on the chimney exterior shaft after water jet cleaning

For the removal of the old paint coats and the degraded concrete layers a directed water jet with up to 120 MPa pressure was used. After the cleaning of the outer chimney shaft there followed repair of the cracks, with the main goal of sealing them to prevent the penetration of water and aggressive materials to the inner concrete and to the reinforcement. Due to the various widths of the cracks three methods for the crack repair were proposed and carried out:

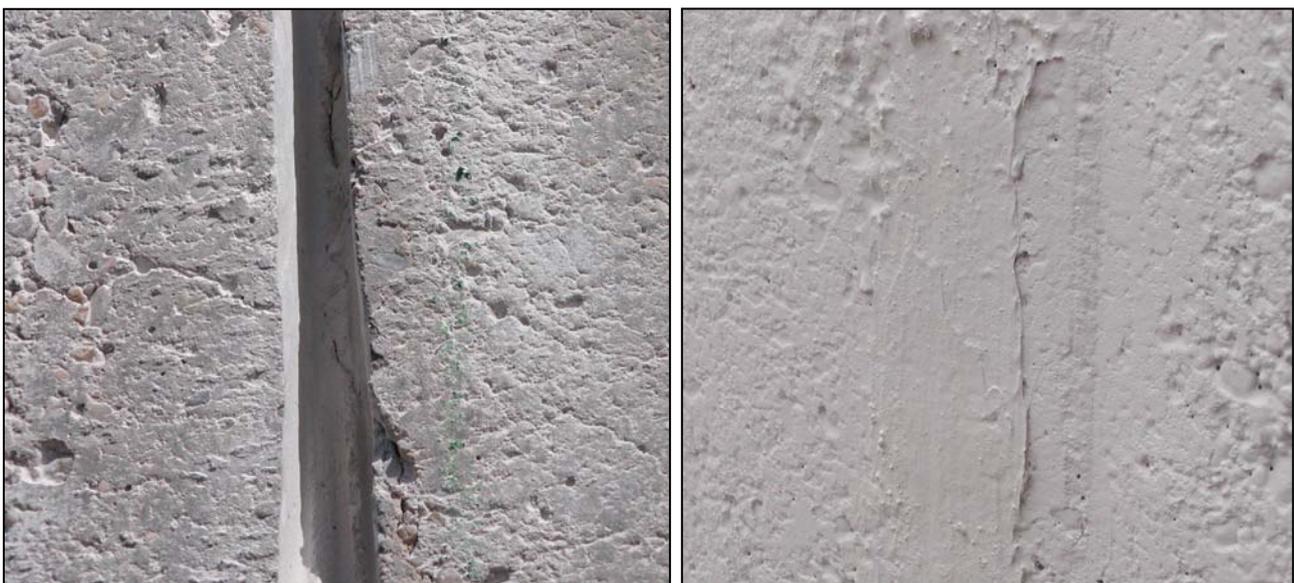
Fig.4 Rehabilitation of large cracks

- Cracks up to 0,5 mm wide were covered and sealed by a flexible coating system, SIKAGARD 552W, which was used for the secondary protection of the outer chimney surface. This is capable of covering changes in the crack width of up to 0,3 mm.
- Cracks of width from 0,5 to 1,0 mm were sealed by an injection of flexible injection material on a base of polyurethane resin.
- Cracks of width greater than 1,0 mm were cut by a carbon grinder with a diamond disc for gaps of depth 20 mm and width 10 mm. After cleaning the gaps, PE cord with a diameter of 10 mm was pressed into the gaps. Following this, the wall gaps were penetrated with PRIMER SIKA 3 coating paint, and finally the gaps were permanently sealed with SIKAFLEX PRO 3 WF flexible putty. (Fig. 4).

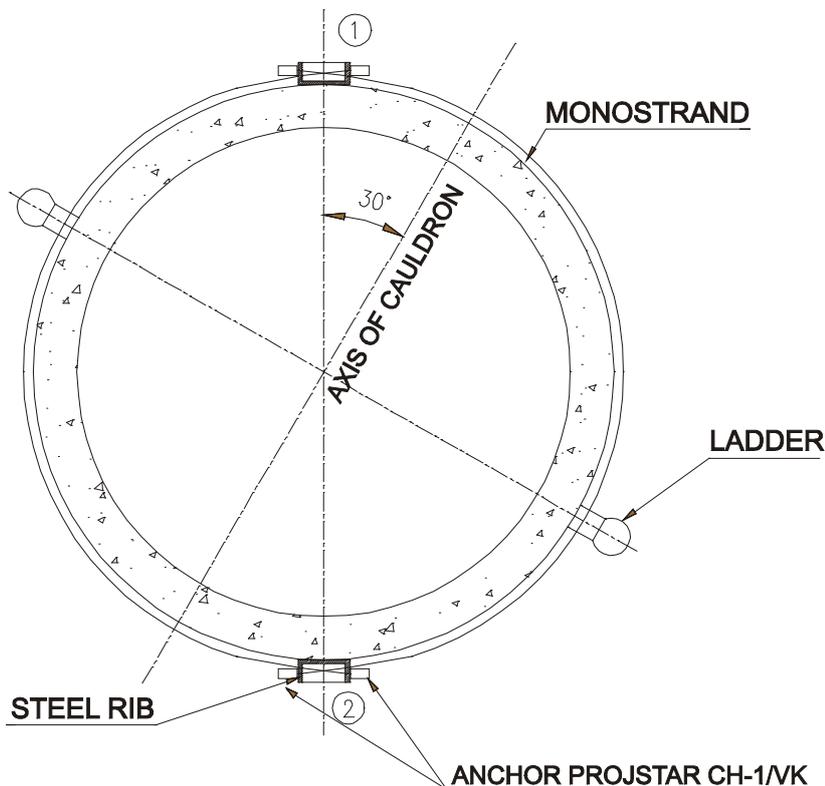
Fig. 5 Scheme of external prestressing of the chimney

External prestressing was used from a height of +17,5 m to height +132,5 m. In total 310 cylinders of Monostrand tendons were proposed along the height of the chimney divided as follows: 50 x 300 mm + 44 x 340 mm + 175 x 400 mm. The upper part of the chimney, in a length of 14,0 m, was strengthened by steel bands at a distance of 1,0 m. The prestressing tendons were alternately anchored in steel ribs no. 1,2 by PROJSTAR single-cable anchors (Fig. 5). Monostrand was manufactured such that it resisted the increased loading from local unevenness of the chimney surface and the sun's rays. The thickness of the UV stabilized HDPE polyethylene is 2 mm. The colouring of the polyethylene corresponds to the colour tones of the chimney. The basic shade of the polyethylene is silver-grey. In warning-band places, red-coloured polyethylene was used. The closed cylinders of the pre-stressing reinforcement are anchored in one of a pair of opposed ribs. The anchored ribs are manufactured from U-profile rolled steel of a height of 140 mm. In the area of anchoring of the tendon, the U-profile is reinforced by steel reinforcements of a thickness of 8 mm. An HDPE guard runs through holes in the rib, thus increasing the protection of the Monostrand against damage by notched pressure. The ribs are anchored to the chimney shell by steel anchors of width $\varnothing 12$ mm. The anchoring ribs were manufactured in previously established lengths and their surface was treated with heat galvanizing. The Monostrand tendons are anchored in the ribs by a pair of PROJSTAR CH-1/VK single-cable anchors (Fig. 6). The anchor is treated by a zinc coating, and is treated so that leaking of the anchoring casing does not occur. Permanent plastic bitumen putty was used to seal the connector and the protective cover, and the interior space of the anchoring was filled with lubricant.

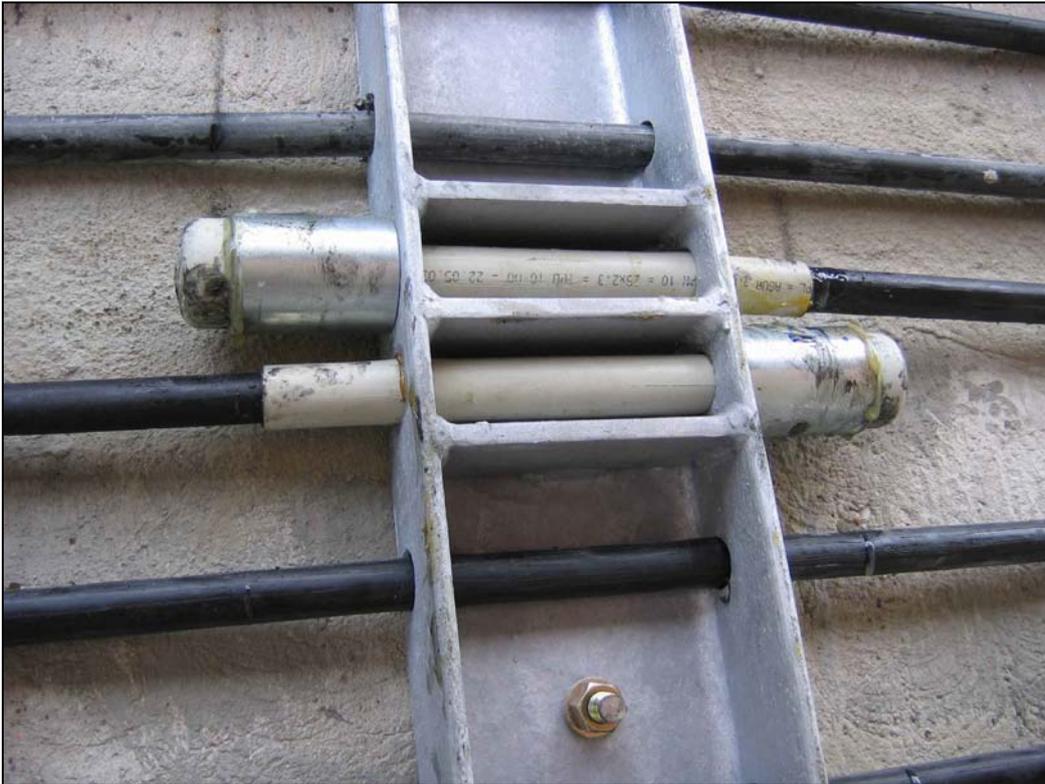
Fig. 6 Anchoring of the Monostrand tendon

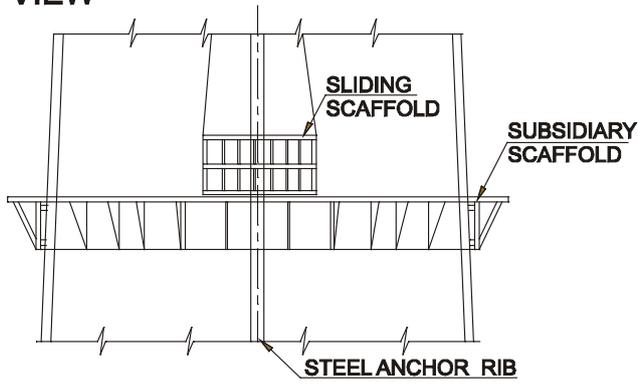
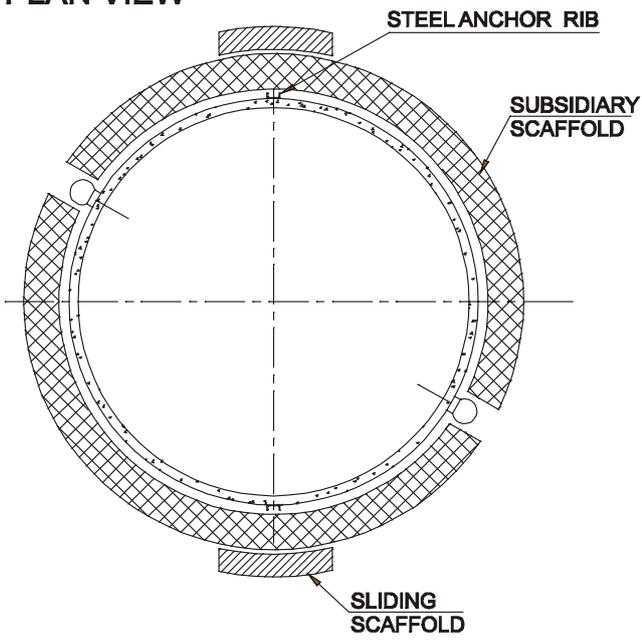
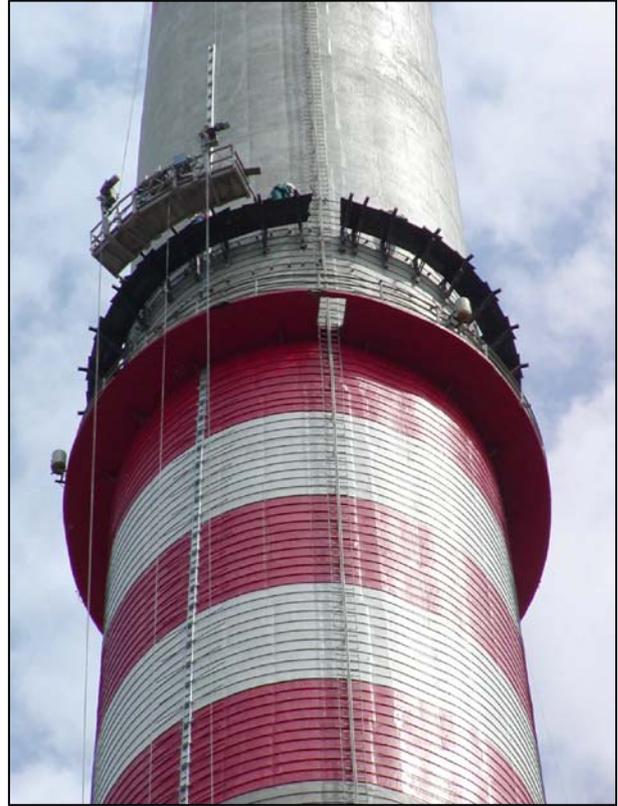
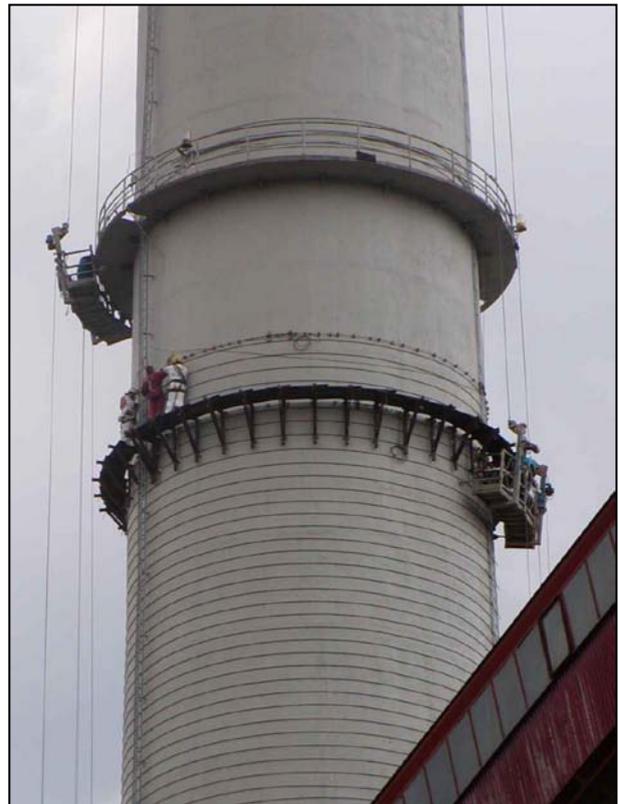
Fig. 7 Installation of prestressing tendons

The assembly was carried out from two scaffolds which moved along the vertical lines of the anchoring. For the assembly of the prestressing tendons the scaffolds were augmented by additional scaffolds (Fig. 7), from which it was possible to progressively place the tendon and stabilize its course by simple determiners of the tendon position. After the fixing of the anchors, the tendon was stressed to the calculated force of 65,5 kN. The speed of assembly of the tendons was limited mainly by the relocation of the additional scaffold. In 3 daily lintels of the scaffolding it was possible to assemble 20 tendons.

The stressing of the tendons to 180 kN was performed after the completion of the assembly of all the tendons. The stressing process was carried out so as to avoid the bending of the ribs on one side. For the prestressing were used two PAUL TENSA SM200 kN sets with special press extensions, which angled the press from the chimney wall.

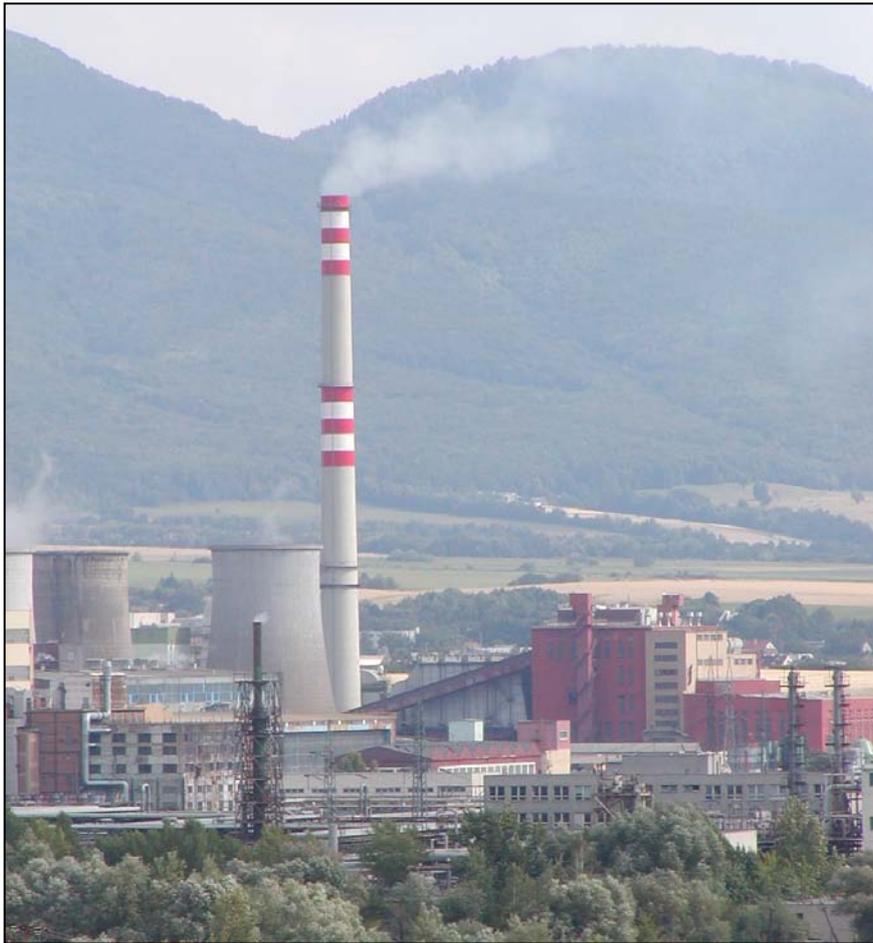
Fig. 8 The view of finished chimney

The rehabilitation work on the chimney started in September 2002 and was completed in May 2003. The winter season made necessary the interruption of the work for 4 months. During its execution, greater stress was placed on quality, which was overseen by two independent organizations. Part of the project includes ongoing monitoring of the finished work. A view of the rehabilitated chimney is found in Fig.8.
