EXPERIMENTAL AND IN SITU STUDY OF BRIDGE BEAMS SUPPORTED BY BOTTOM EXTERNAL TENDONS

Doc. Ing. Milan Chandoga, PhD., Projstar PK, Bratislava, Slovakia
Doc. RNDr. Andrej Jaroševič, PhD., Projstar PK, Bratislava, Slovakia
Ing. Ján Sedlák, Faculty of Civil Engineering, STU, Bratislava, Slovakia
Ing. Eduard Sedlák, Inžinierske stavby a.s., Košice, Slovakia

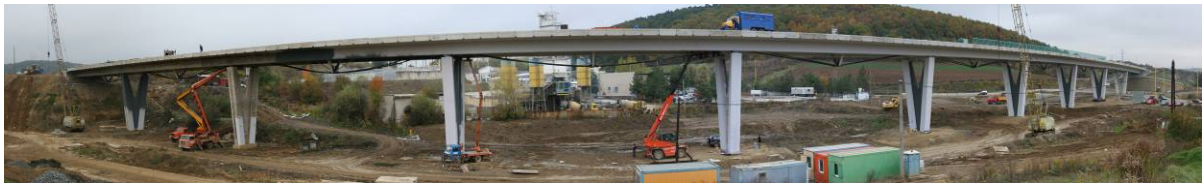
Fig. 1 Panoramic perspective of the whole bridge structure during the construction period

Viaduct 215-00 (Fig. 1 and Fig. 2) is located on the highway D1 Fričovce – Prešov west (Slovakia) and is designed as continuous post-tensioned slab with 2 beams, supported in the middle of the spans by tendon ties. The span lengths are $29 + 8 \times 35 + 29$ m, and the total bridge length 347 m (Fig. 8). A similar bridge construction viaduct Osomort in Girona (Spain) was implemented in the 1990s, and this bridge is considered to be a highly successful technical and architectural construction. Structural systems of bridges with high eccentricity external cables are still very popular in present times. External tendons located under the bridge slab in the form of ties are placed outside the bridge contour because of the higher effectivity of prestressing. These structural systems are classified in the same bridge category as extradosed bridges.

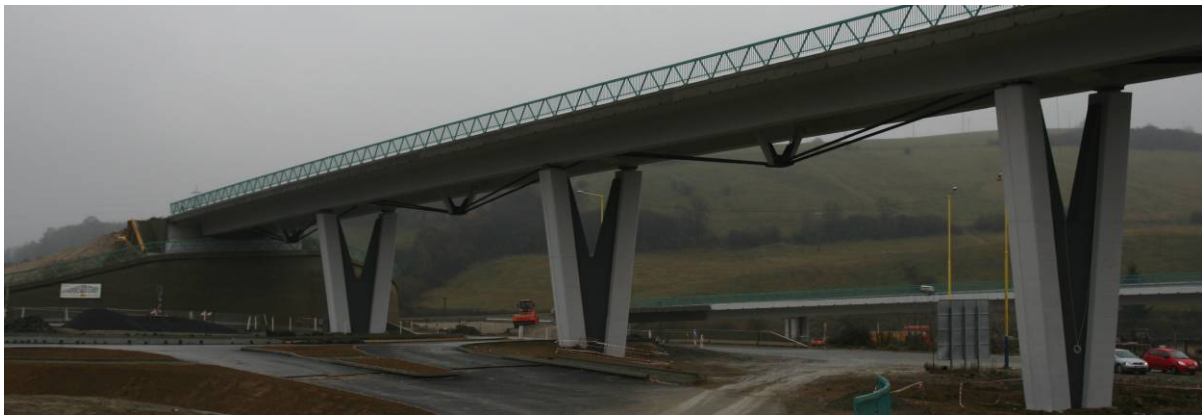
Fig. 2 Part of viaduct 215-00 during the construction period

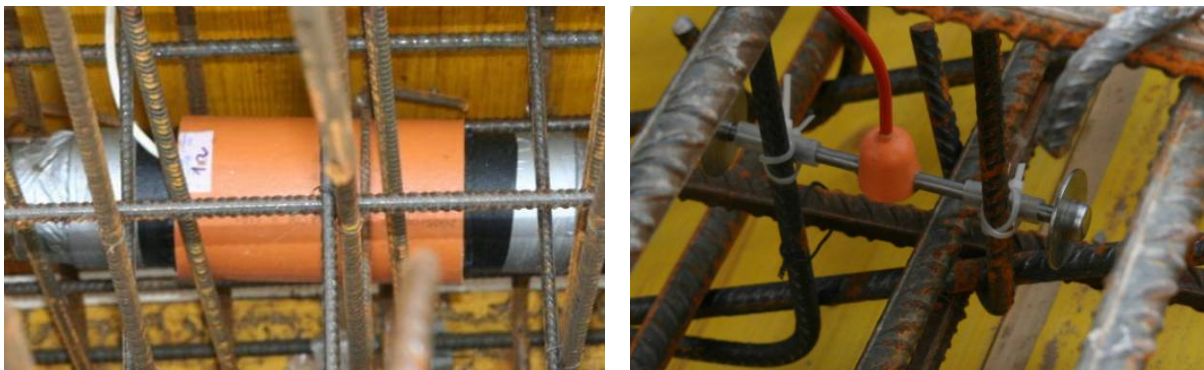
Fig. 3 EM transducer embedded on corrugated steel sheath (left)

Fig. 4 Vibrating wire strain gauge embedded on steel reinforcement (right)

Measurement of stress in selected bonded 12 - 19 strands tendons was carried out with EM transducers PSS90 (Fig. 3). Globally were embedded 14 pieces of EM transducers PSS 90, of which one as compensatory (Fig. 5).

EM transducers PSS90 for measuring of force (Fig. 3) were embedded on tendons K1ab (12 strands, tendon length 85,3 m), K2a (13 strands, tendon length 84,6 m), K2bc (13 strands, tendon length 72,7 m), K3a (12 strands, tendon length 47,2 m) and K4a (19 strands, tendon length 84,0 m) in such positions for monitoring of initial prestressing force and its transmission over the length of the tendon (Fig. 5).

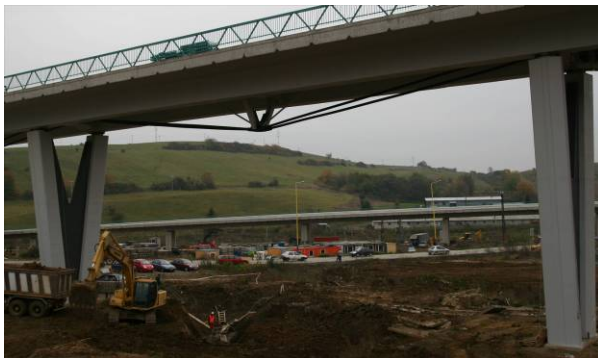
Fig. 12 External tendons on the bridge and layout of Monostrands in tendon

External tendons (Fig. 12) have a simple geometry in the form of a “V” and they are assembled from Monostrands, which are pulled to the HDPE duct with an outer diameter of 140 mm (Fig. 12). The position of end anchoring and the direction of the tendon in the cross beam do not allow the use of a 19-strand stressing jack. That is why a single stressing jack was used for the external tendons. After the completion of tendon prestressing, the HDPE duct was filled with grouting.

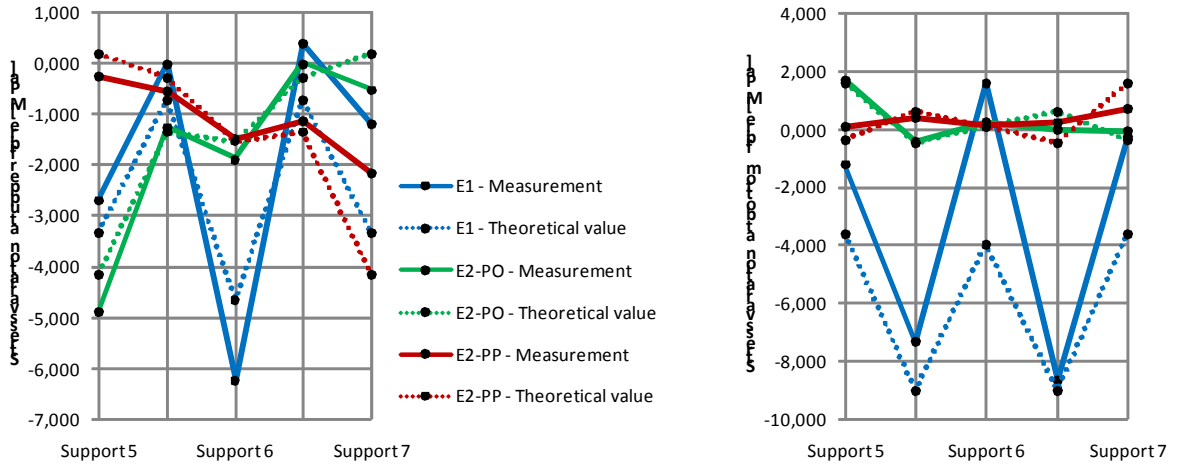
Fig. 14 Stress variation in stages of bonded tendons prestressing

Stress measurement in the concrete was carried out with vibrating wire strain gauges. For computation of stress values from measured strains, the modulus of elasticity from concrete specimens – cubes, prisms and cylinders (strength class for concrete C35/45) from each building stage was evaluated. The modulus of elasticity was controlled by 3 independent laboratories – in situ, supervisor and technical institute, separately for specimens from concrete casting of beams and concrete casting of the bridge slab. For theoretical analysis of the first building stage values 33 GPa for beams and 32 GPa for the bridge slab were then used. The age of the specimens represents the time from concrete casting till prestressing of the tendons. In Fig. 14 are shown comparisons of the stress variation between theoretical computing and measurement for 3 building stages (prestressing of bonded tendons in stage 1 – E1, stage 2 in the direction to city Prešov – E2-PO and stage 2 in the direction to city Poprad – E2-PP). The only difference is in the stress variation for stage 1 – E1, when the

whole bearing structure was still bedded in the formwork and values achieved different results compared to the exact computational model with defined supports (pillars and formwork).

Measured stress variations in the concrete for the first building stage (E1), when the whole bearing structure was still bedded in the formwork show different results compared to the exact computational model with defined supports (pillars and formwork).

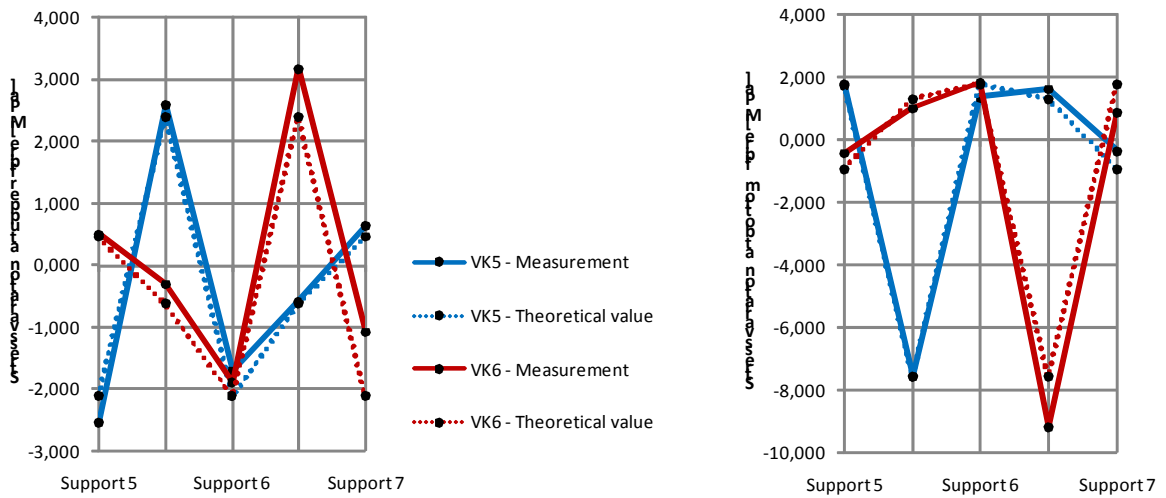
Fig. 15 Stress variation in stages of external tendons prestressing

In Fig. 15 are shown comparisons of the stress variation between theoretical computing and measurement for prestressing of external tendons VK5 in span 5 and VK6 in span 6. The results show nearly equivalent values.

Measured stress variations in concrete after the prestressing of the second building stage from both sides (E2-PO, E2-PP) and prestressing of external tendons VK5 and VK6 in the 2 middle spans correspond to theoretical assumption.
